222 Church Road

Cheltenham Township, Montgomery Co., PA

EROSION & SEDIMENTATION POLLUTION CONTROL REPORT

REB No.: 2154-10

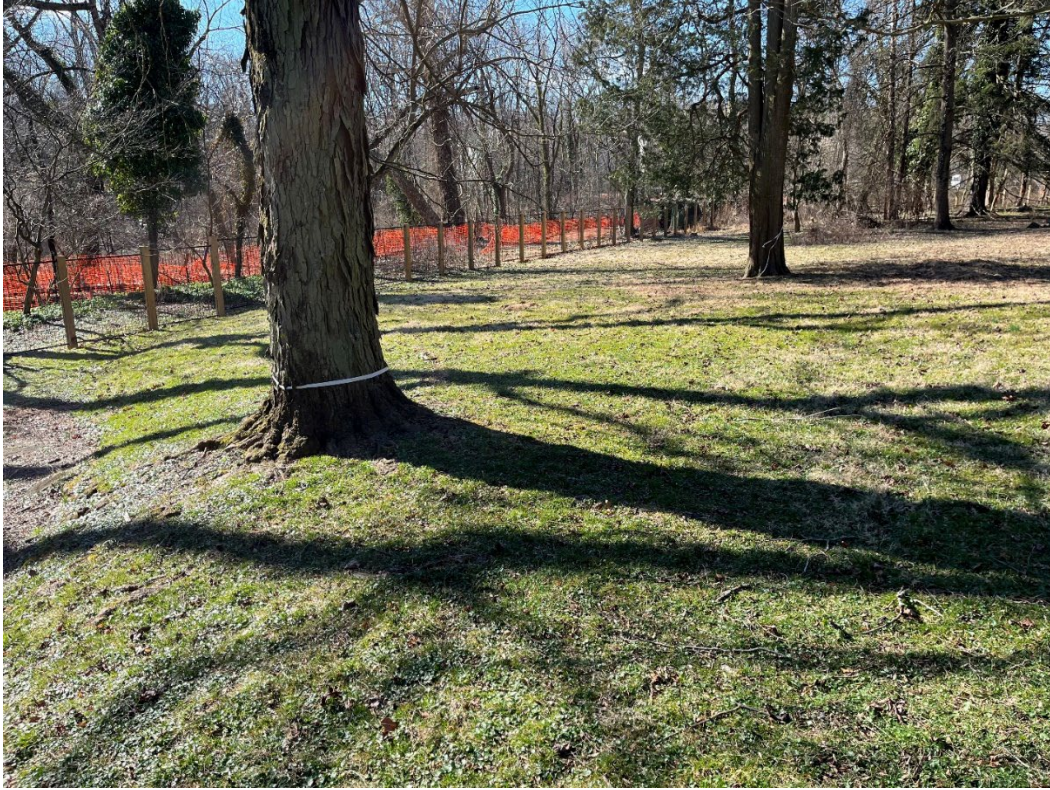
Figure 1 - Photograph of the southern edge of the property facing towards the southwest corner. Looking towards POD #1 near the left portion of the photo.

The site drains in a southerly direction towards the Tacony Creek (A.K.A. Tookany Creek). The project has been determined to contain two (2) distinct study points, defined as Point of Discharge (POD) #1 and POD #2. POD #1 has been defined as the portion of the site that drains to Tookany Creek upstream of the recently constructed Township trail crossing of Tookany Creek and coincides with the discharge location of the proposed above ground infiltration basin (BMP ID 001) located along the rear of Lots 6 thru 8. POD #2 has been defined as the portion of the site that converges to the on-site wetland (Wetland A) and ultimately Tookany Creek downstream of the recently constructed Township trail crossing of Tookany Creek. In the existing conditions, both POD's receive primarily sheet flow and shallow concentrated flow from the upland residential properties. There are no distinct stormwater facilities or outfalls that drain to these POD's in the existing conditions and there are no signs of accelerated erosion resulting from drainage within the development area.

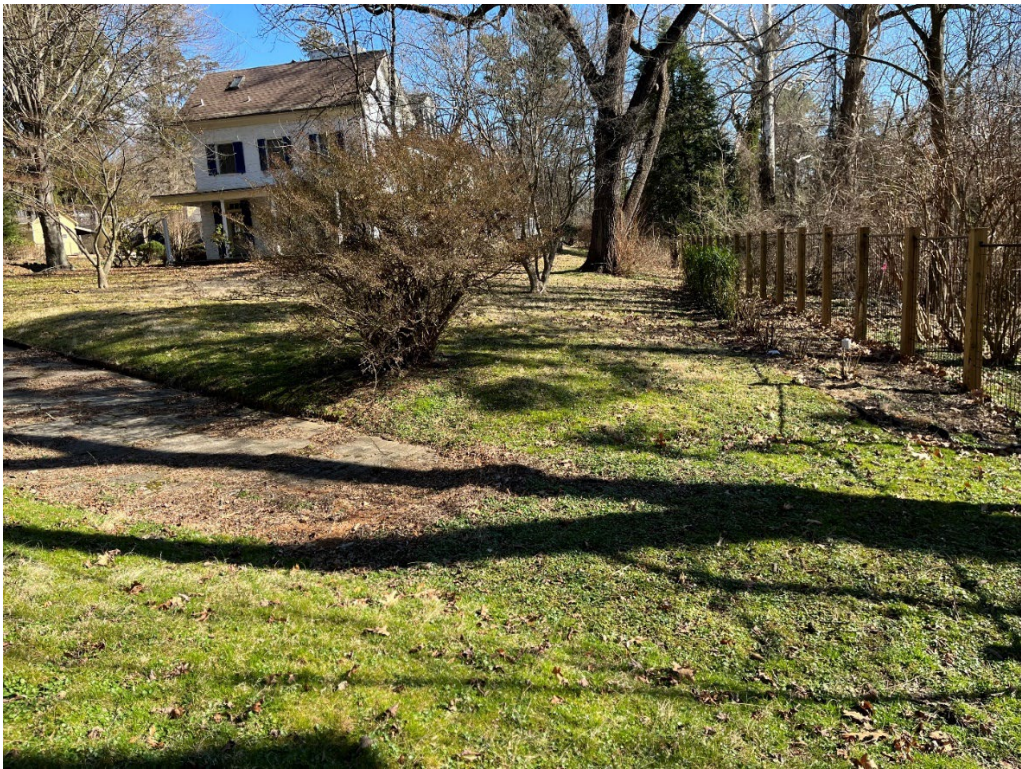
Figure 2 - Photograph of the southern edge of the property in the vicinity of POD #1 facing towards the southeast corner.

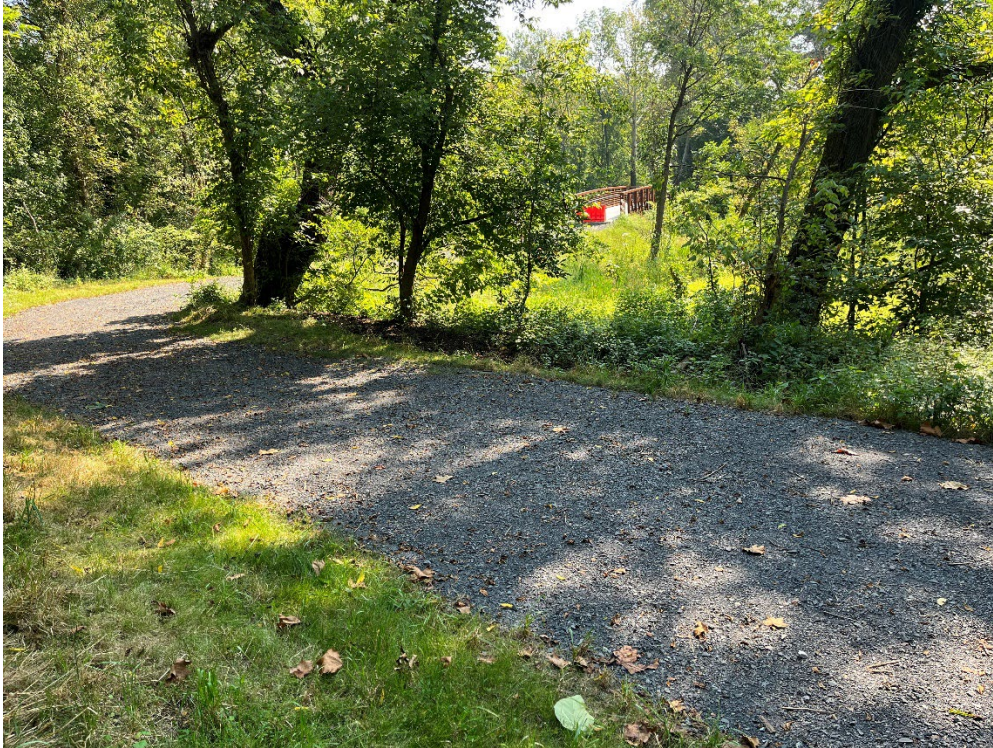
Figure 3 - Photograph from the vicinity of POD #1 looking southeast towards the Township trail. The existing berm can be seen beginning at the bend in the trail. Runoff that crosses the trail gets redirected by the berm and flows to the southwest towards the opening in the berm.

From POD #1, runoff converges at a berm just downstream of the recently constructed Township trail. Runoff then flows through an opening in the berm down a slope to low-lying area within the floodplain of Tookany Creek and ultimately into Tookany Creek itself. The flow path from POD#1 to Tookany Creek is fully on Township-owned land and the ground cover consists of the Township gravel trail and dense vegetation downslope of the trail. There are no signs of accelerated erosion in the existing conditions.

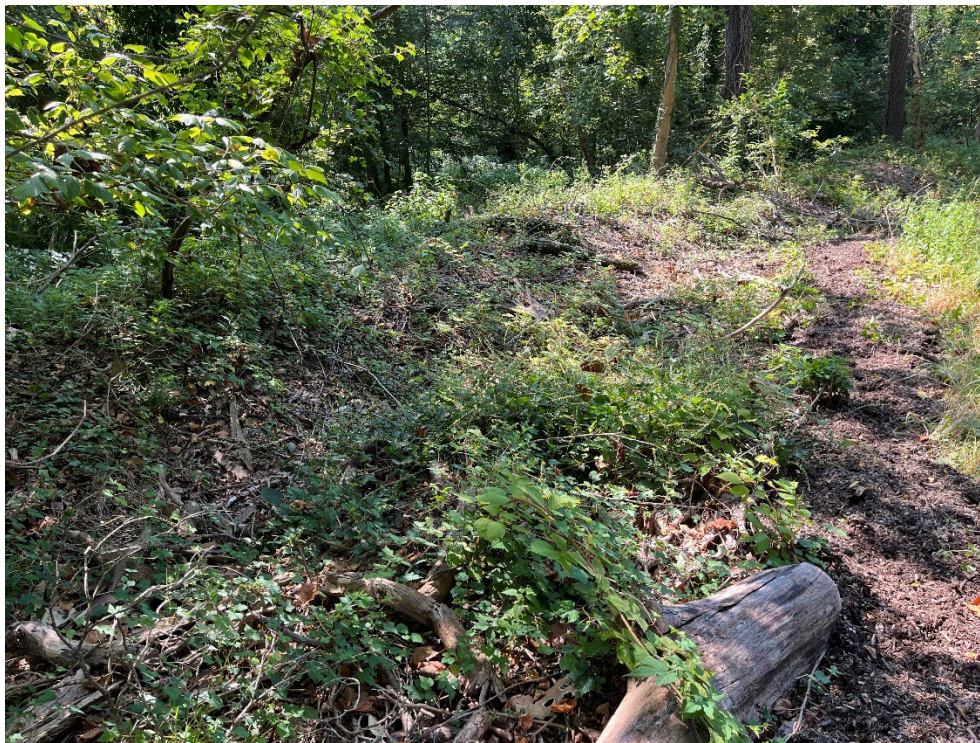
Figure 4 - Photograph along the flow path to receiving waters downstream of POD #1. Standing along the existing berm looking southwest towards the opening in the berm.

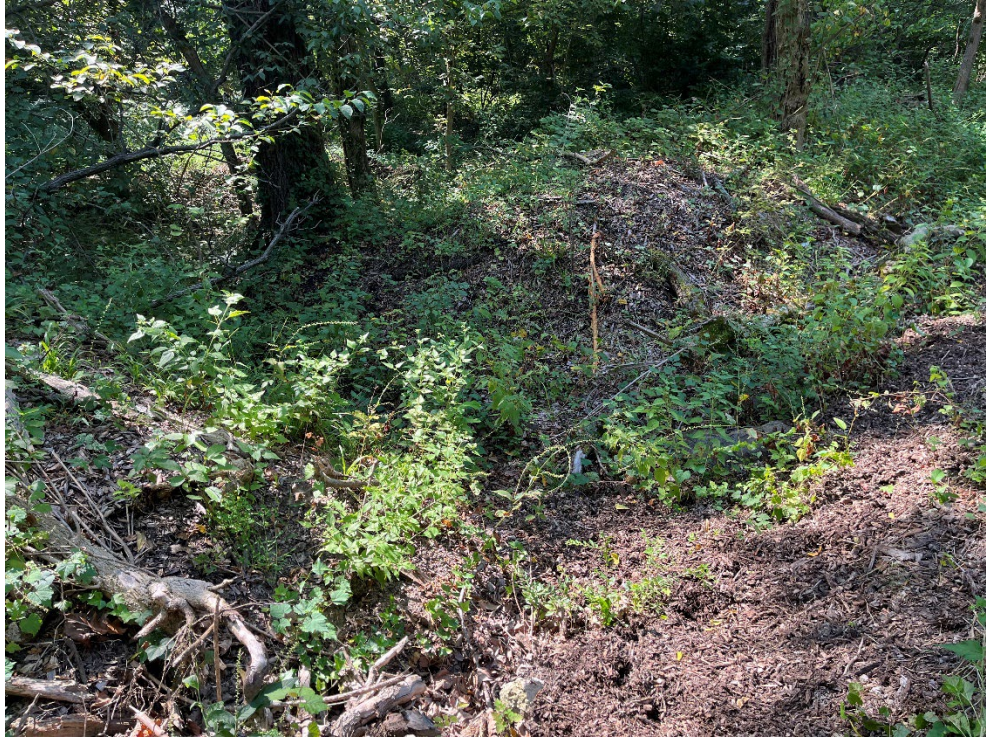
Figure 5 - Photograph of the opening in the berm along the flow path from POD #1 to the receiving waters. Beyond this opening, runoff flows across densely vegetated low-lying land until reaching the Tookany Creek.

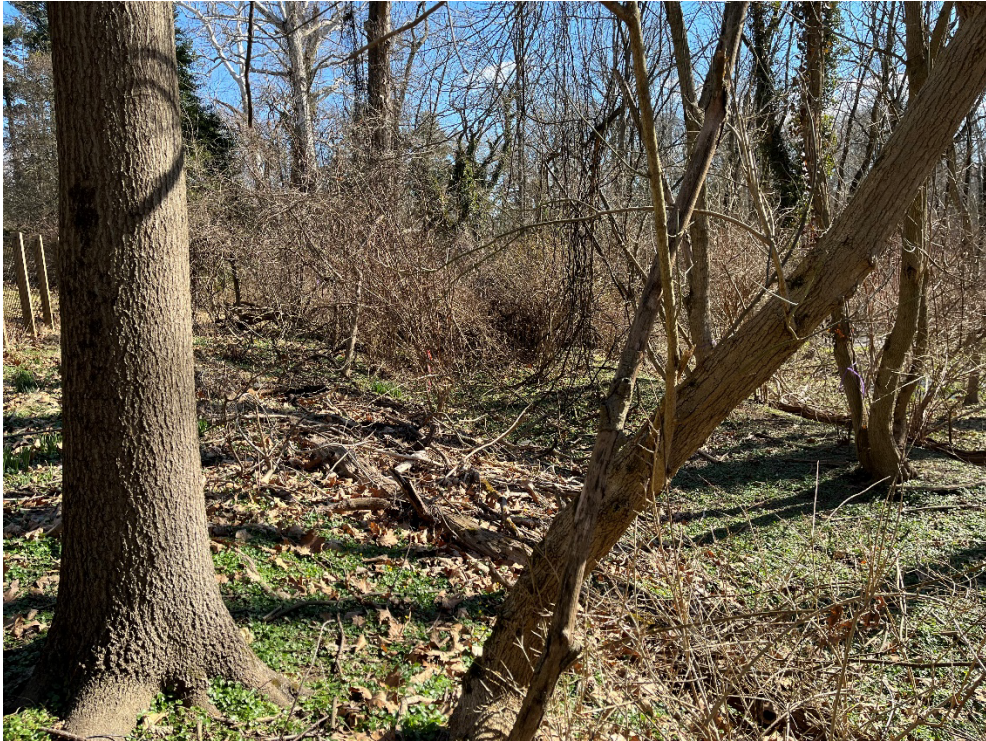
Figure 6 - Photograph of the abandoned & disconnected old mill race at the southern edge of the subject property, facing southeast towards POD #2 and the upper portion of Wetland 'A'.

The project site contains a manmade water conveyance structure reported to have been a mill raceway. This raceway is disconnected from the source of surface water as control structures have deteriorated and berms eroded allowing the outlet of water to Tookany Creek upgradient of the project site. A small on-site masonry structure is labelled as Spring House on the Existing Features Plan. During our site visit in late March following a warm wet winter no spring was present at the Spring House. Function of the spring house is likely impacted by changes to the local hydrologic regime as the result of extensive land development or it may have originally functioned as a root cellar.

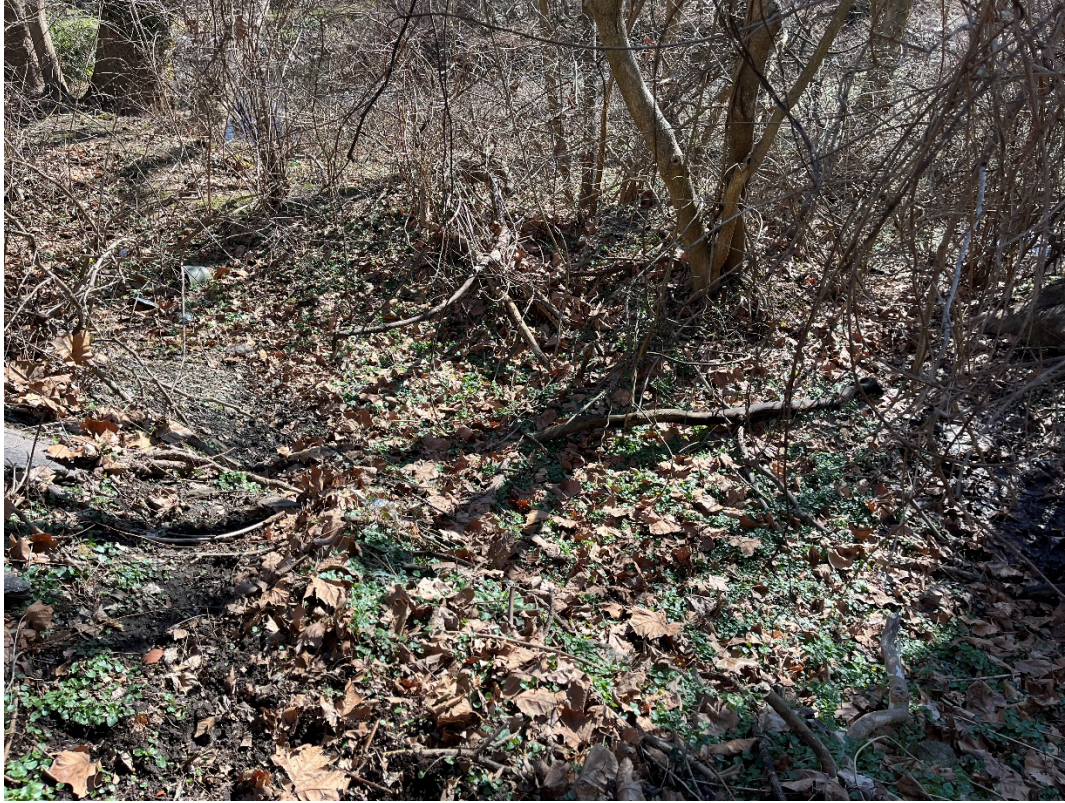
Figure 7 - Photograph in the vicinity of POD #2 and the upper portion of Wetland 'A', looking south towards the opening in the berm that allows surface water to drain downslope to the lower portion of Wetland 'A' and ultimately Tookany Creek.

At POD #2, water converges within the upper portion of Wetland 'A' which is an area where small pools of surface water are present and bound by a berm that was previously part of a manmade water conveyance structure reported to have been a mill raceway. The mill raceway has since been abandoned and disconnected from the source of surface water. From the upper portion of Wetland 'A', surface water flows through an opening in the existing berm and travels downslope to the lower portion of Wetland 'A' along the Tookany Creek floodplain. There are no signs of accelerated erosion in the existing conditions.

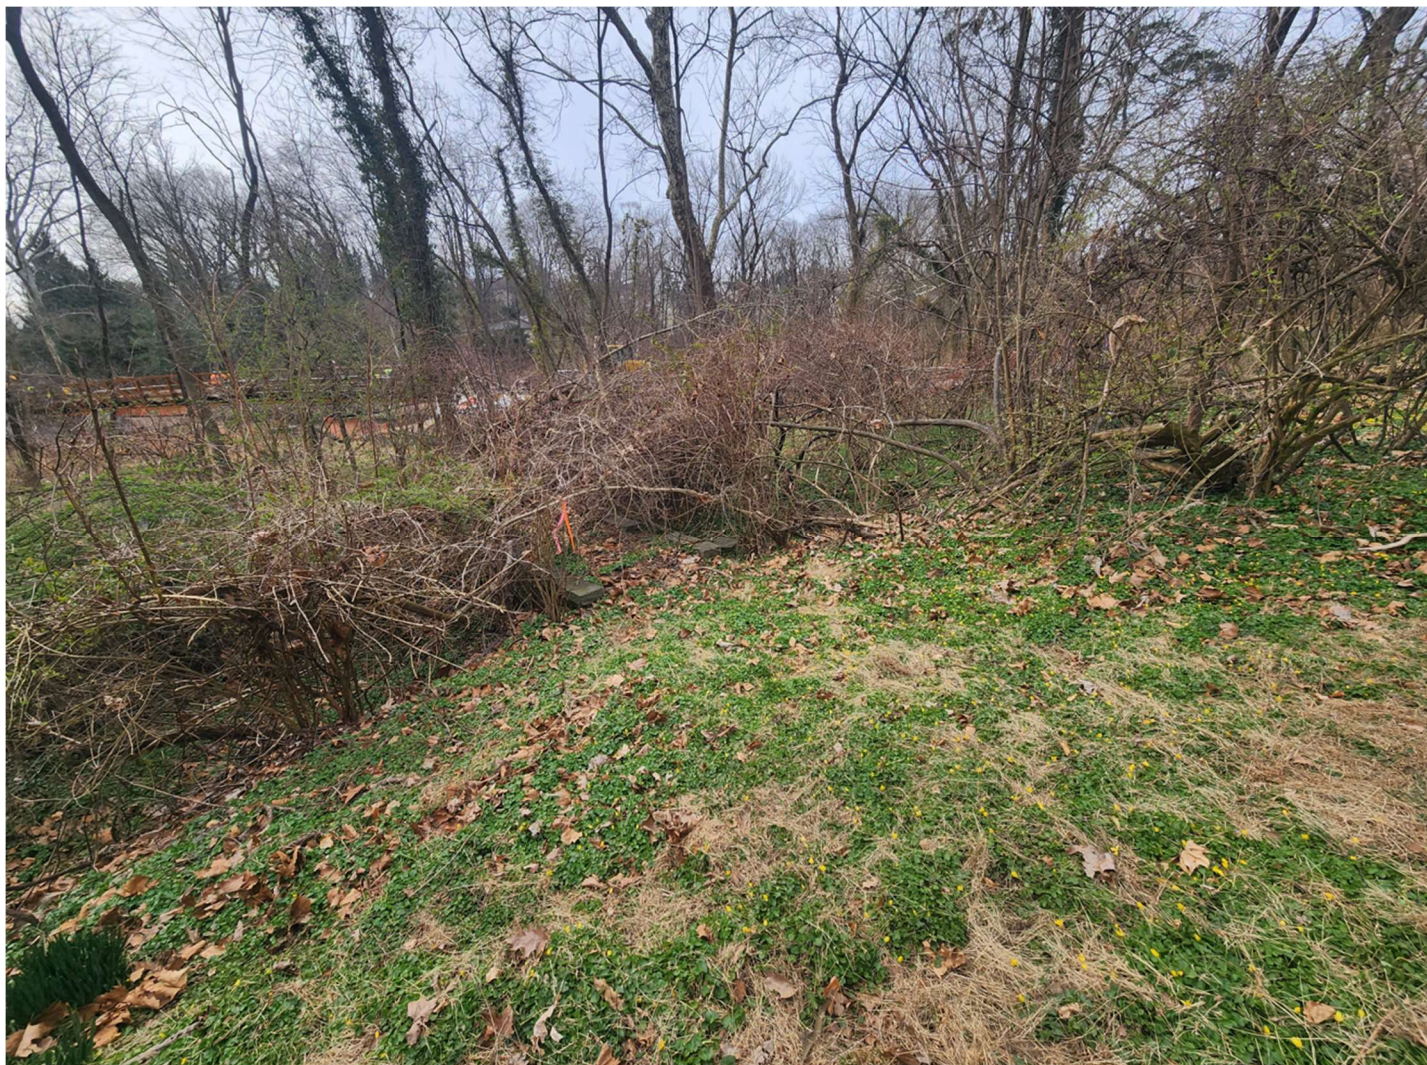
Photo 1: View of Raceway From Lawn; Facing South

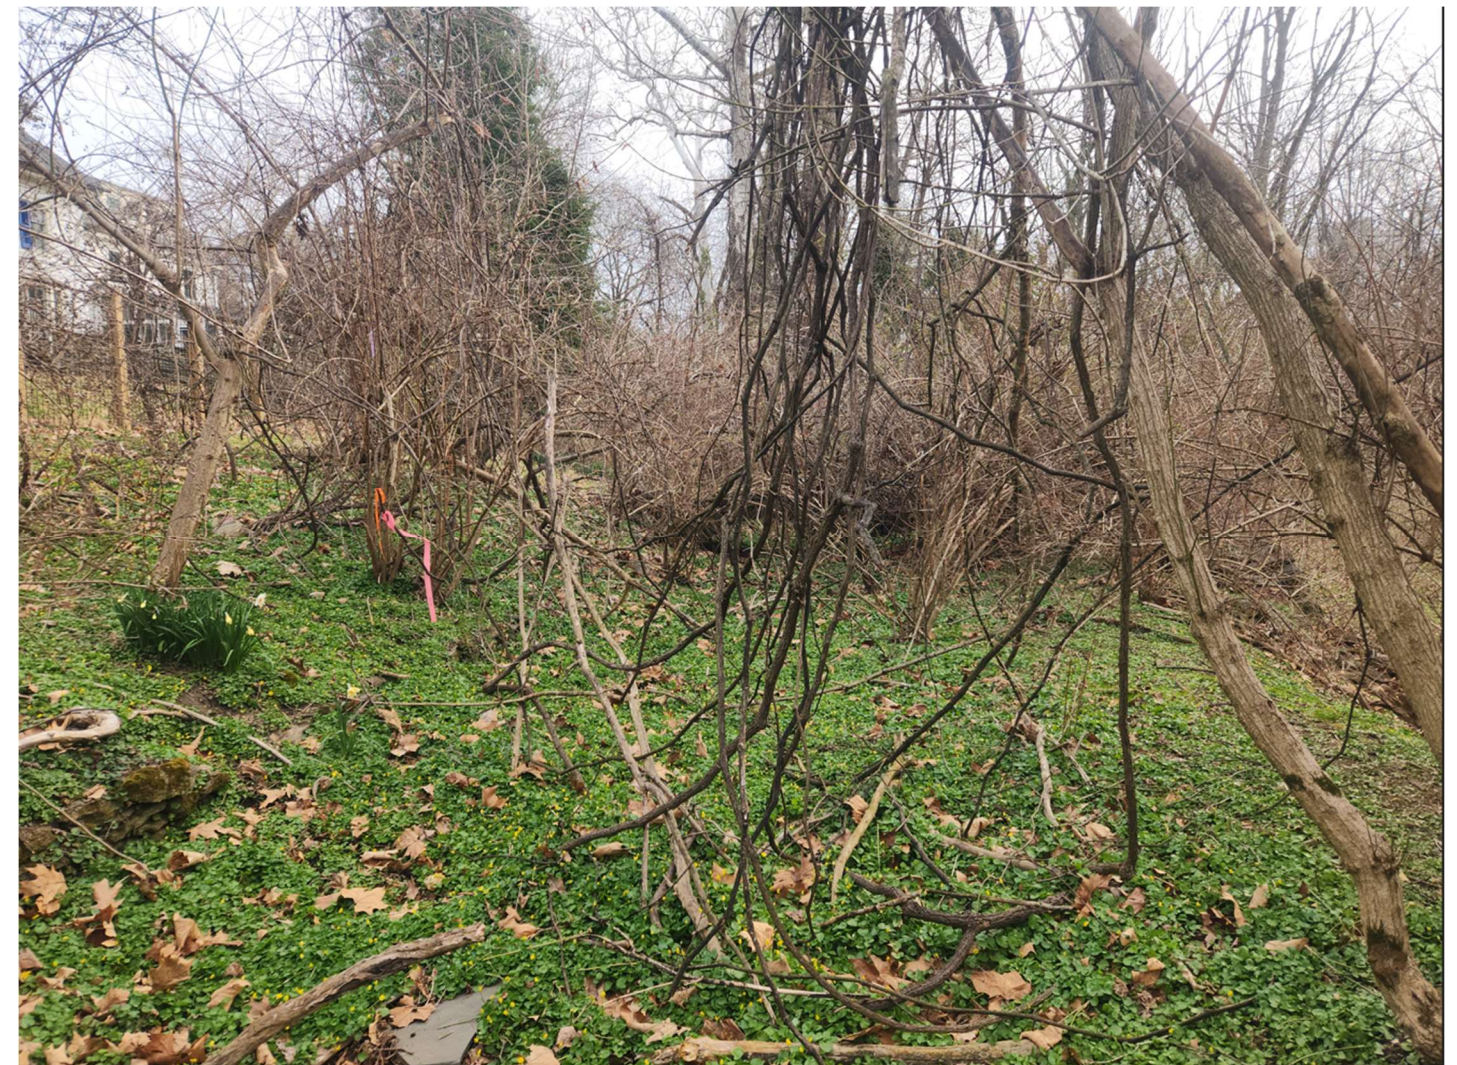
Photo 2: View of Raceway at SP-2, Facing North-northeast

The raceway currently contains a small area of closed grading where surface water is present in small pools at the lowest points. This area meets the criteria of a wetland and was field delineated as such. It is unclear how much of the wetland's hydrology is the result of shallow groundwater or if the wetland is supported by transmission of infiltrated water transmitted via sediment deposits to this low point. To the east and west of the wetland feature the raceway plant communities become more neutral in their affinity for saturated soil conditions and hydrology and hydric soils become absent. The wettest portion of the wetland was unvegetated at the time of our site visit. Margin species include Eurasian buttercup (*Ficaria verna*), boxelder maple (*Acer negundo*), and Amur honeysuckle (*Lonicera maackii*).

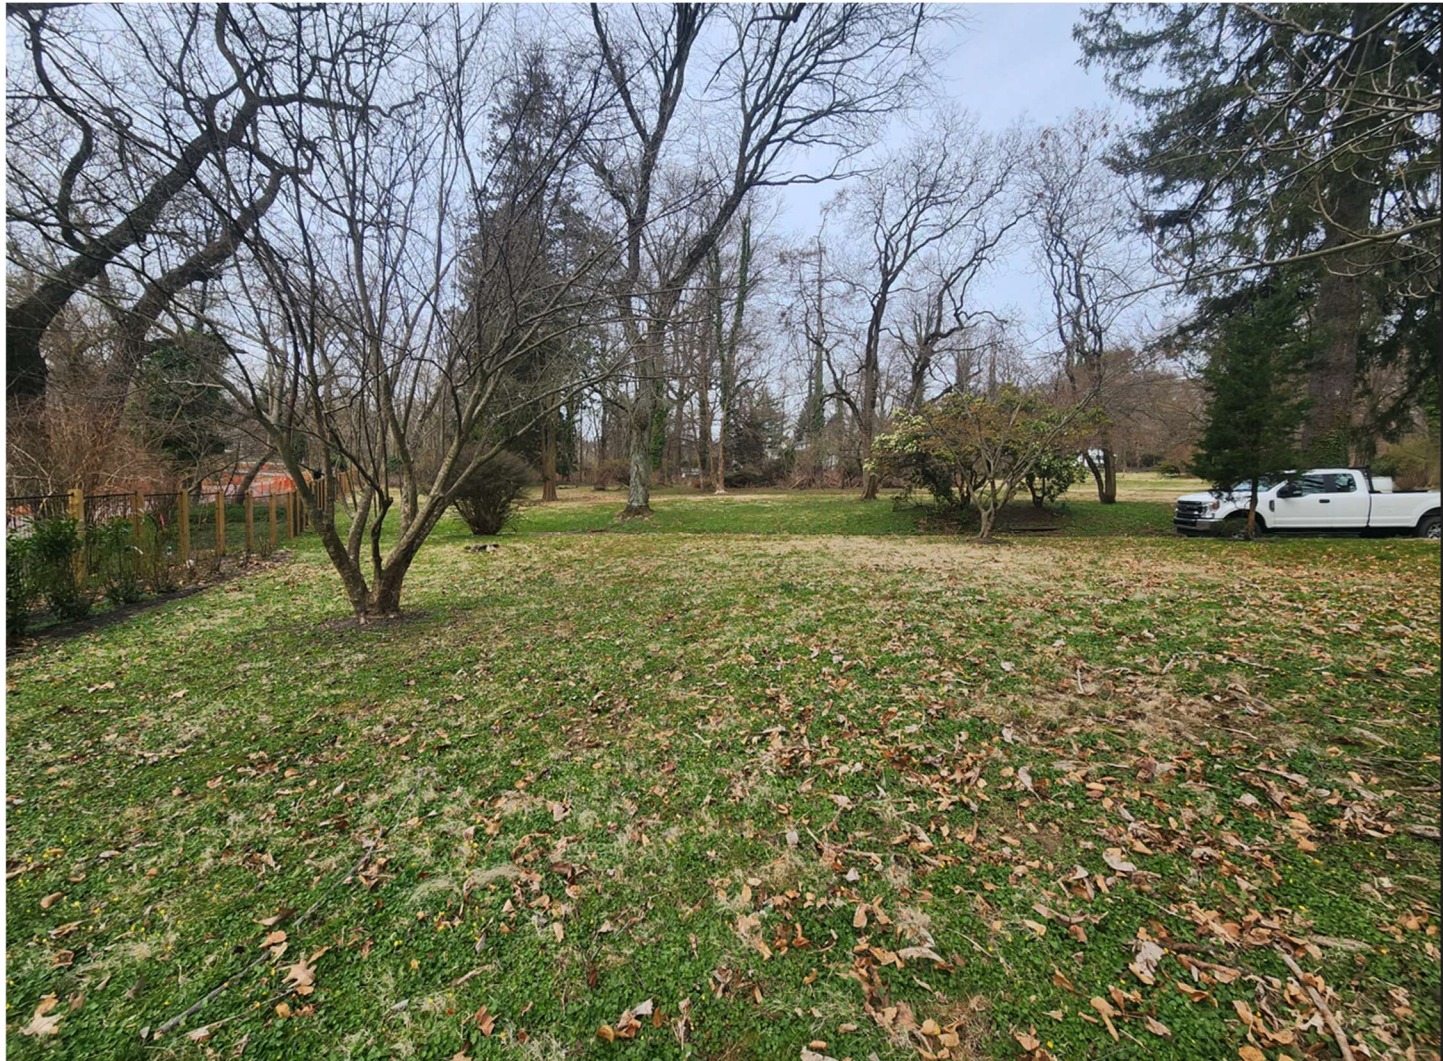
Photo 3: Typical Upland Lawn Condition

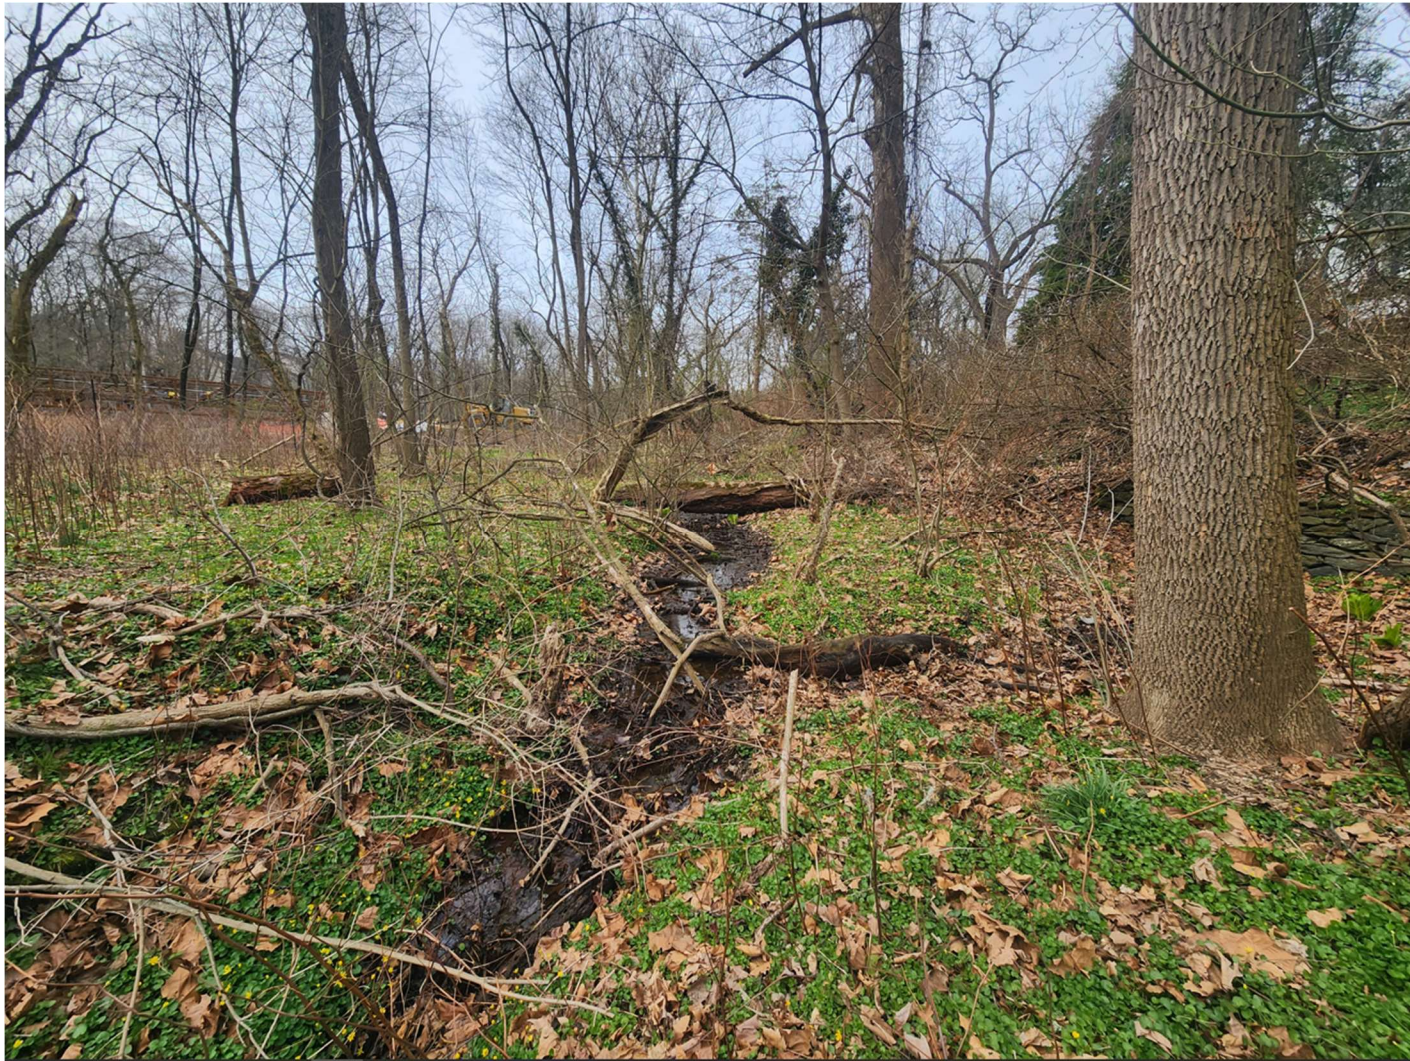
Photo 4: Wetland within Floodplain; Facing West
