**Re: Wetland/Waters Investigation  
222 Church Road  
Elkins Park, PA 19027  
Cheltenham Township, Montgomery County  
TM# 31-00-06637-001**

VW Consultants, LLC (VW) is pleased to present this letter summarizing findings of a wetland evaluation completed on March 22, 2023 at the above referenced property. The purpose of the routine investigation was to identify and delineate wetlands and waters of the US and Commonwealth for a proposed residential land development project. This evaluation area was completed throughout the ±5.05 acres property. The property has frontage Church Road and Harrison Ave with paved driveways from each. The property currently contains a stone dwelling and associated outbuildings. The majority of the property is well maintained lawn with scattered mature trees. Site surface drainage is generally toward the south in the direction of Tookany Creek which traverses neighboring lots.

**FINAL PLAN**  
EXISTING FEATURES

222 CHURCH ROAD  
CHELTENHAM TOWNSHIP  
MONTGOMERY COUNTY  
PENNSYLVANIA

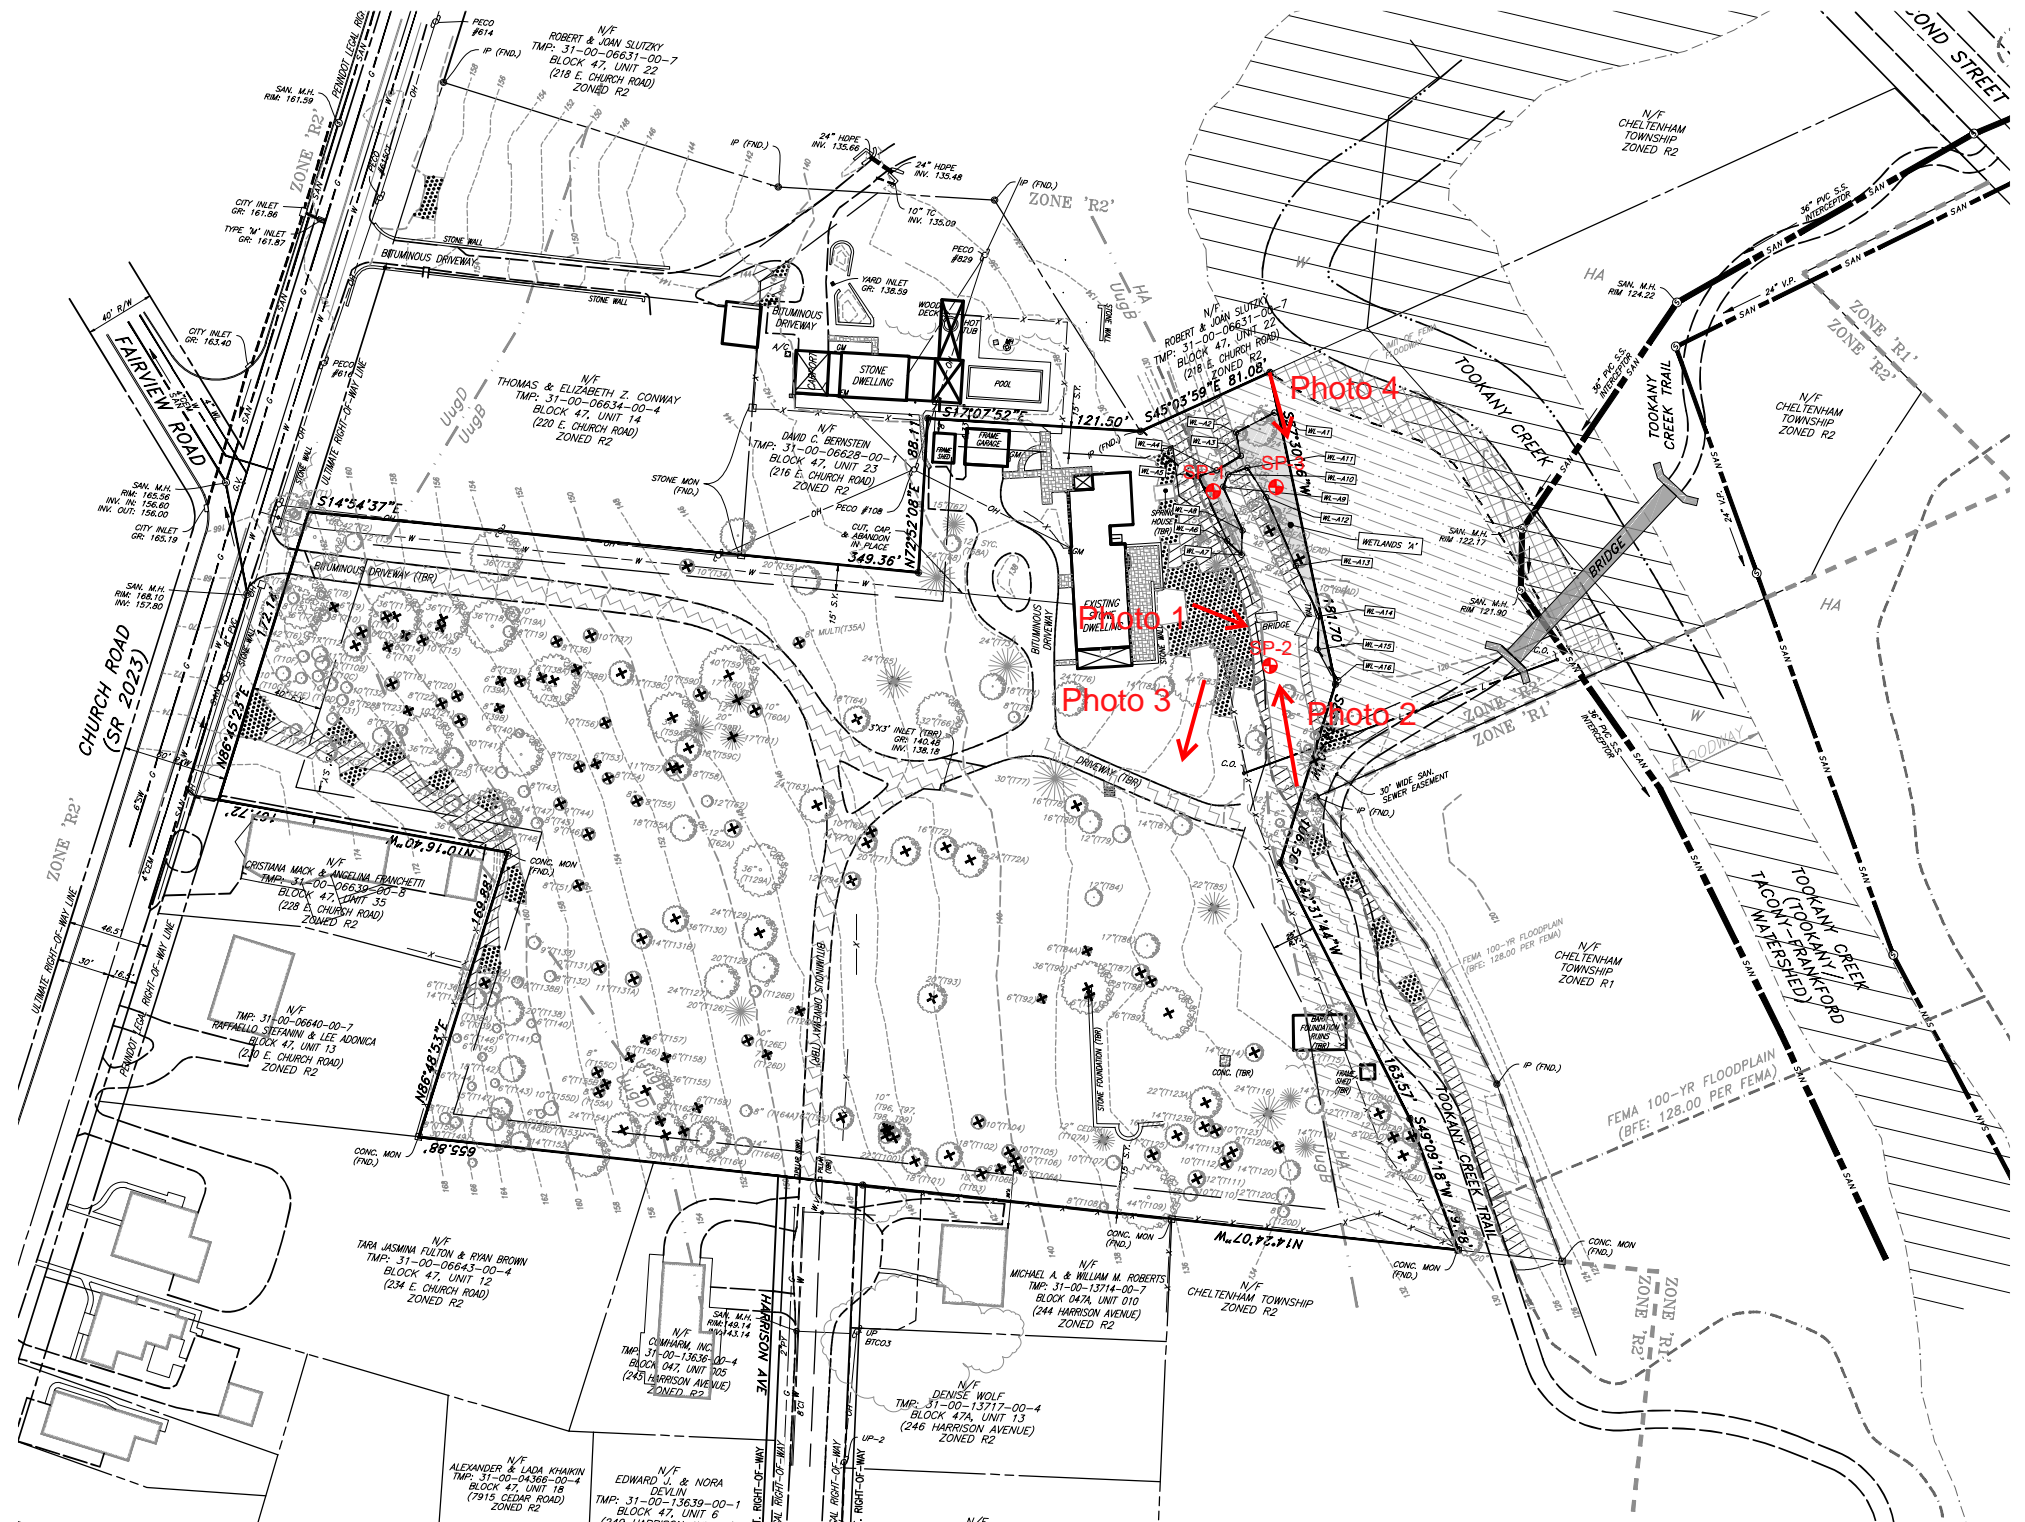
VW traversed the project site to identify plant communities and wetland hydrology indicators. Samples points were located in and along low-lying sections of the site most likely to contain wetlands. The project site and delineated wetlands are depicted on the attached *Existing Features* plan, dated July 23, 2021, last revised April 10, 2023, prepared by Robert E. Blue Consulting Engineers, p.c. Locations of the sample points documented on the attached forms are also indicated on the site plan.

Wetland Sample Point (added by VW)

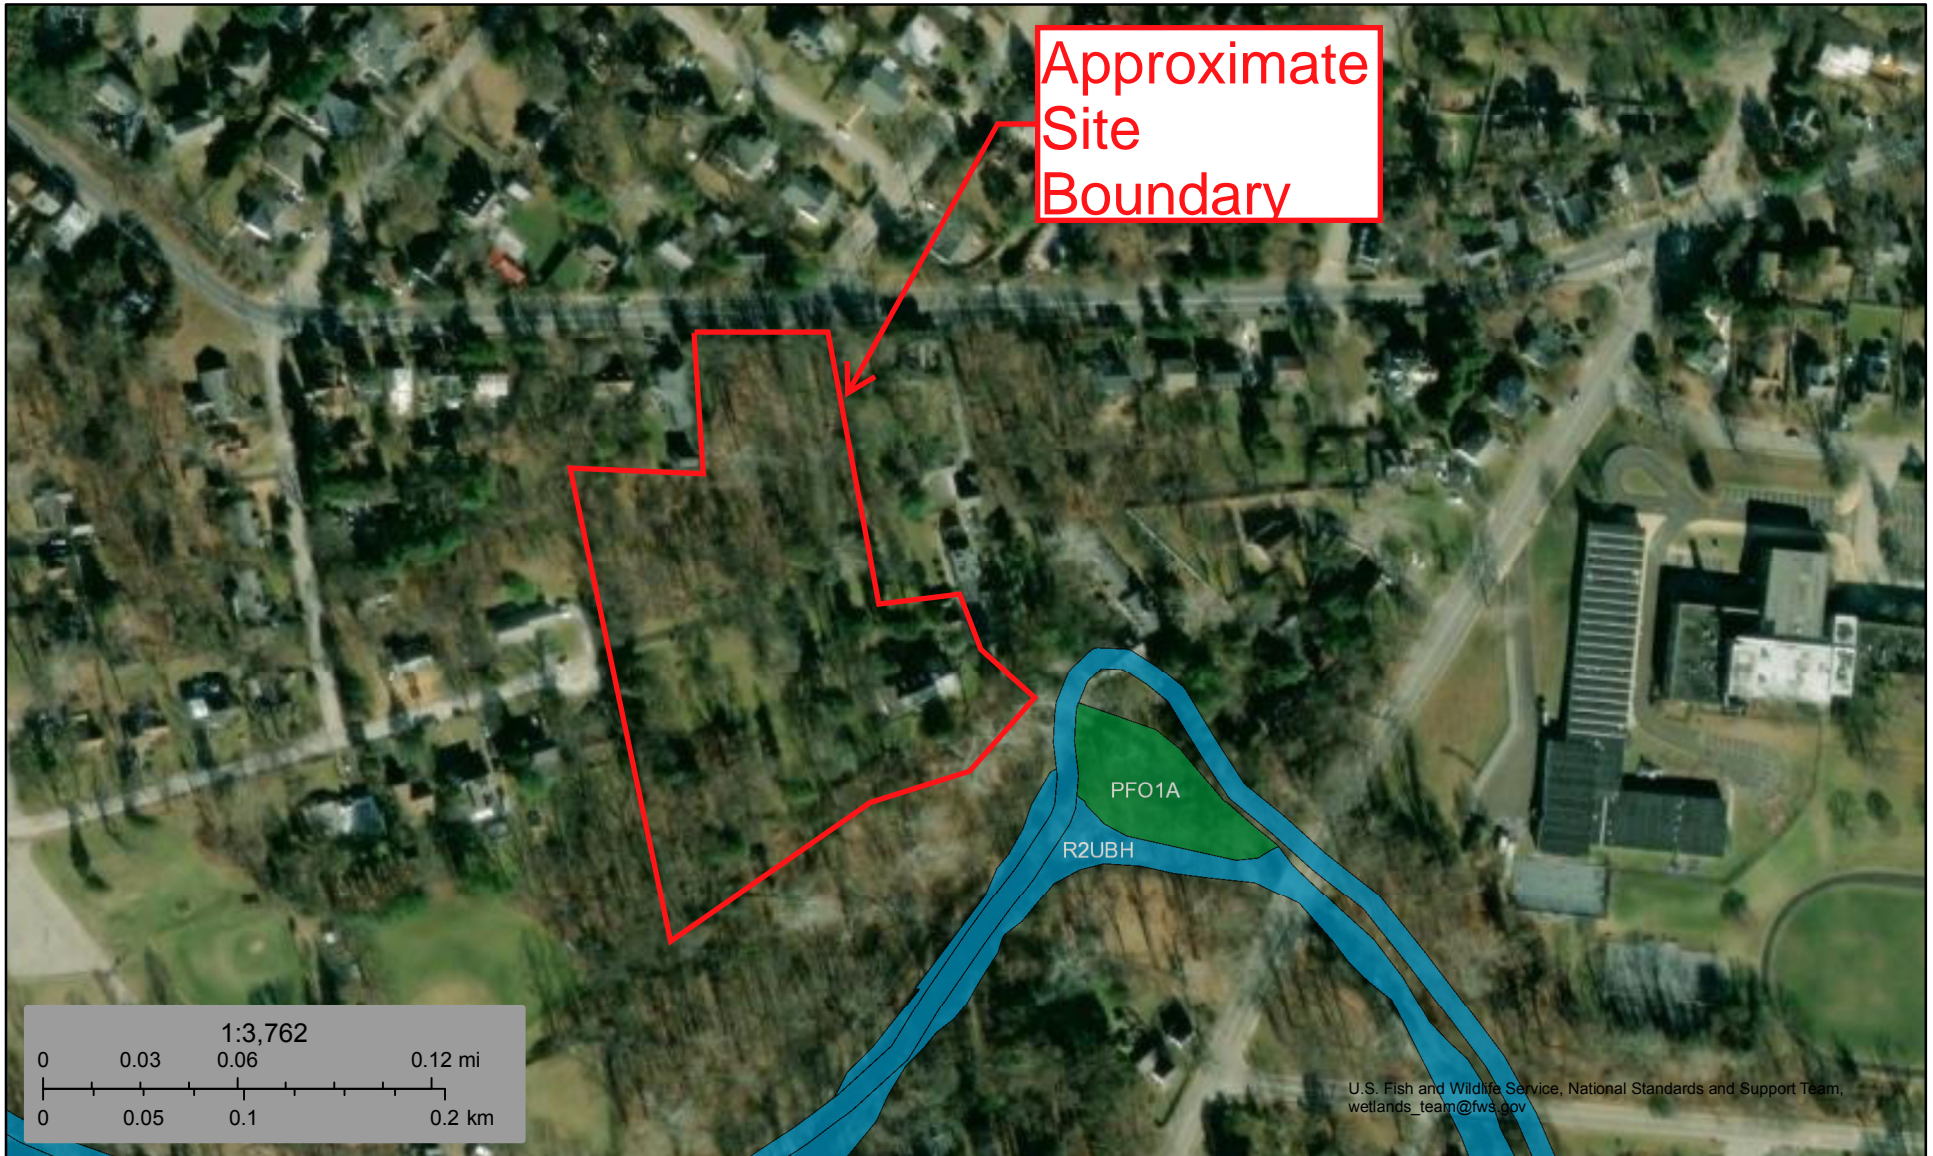
A review the U.S. Fish and Wildlife Services National Wetlands Inventory (NWI) Map revealed presence of riverine habitat associated with Tookany Creek and a forested wetland within the creeks floodway. Both mapped features are off site and down gradient of the project area.

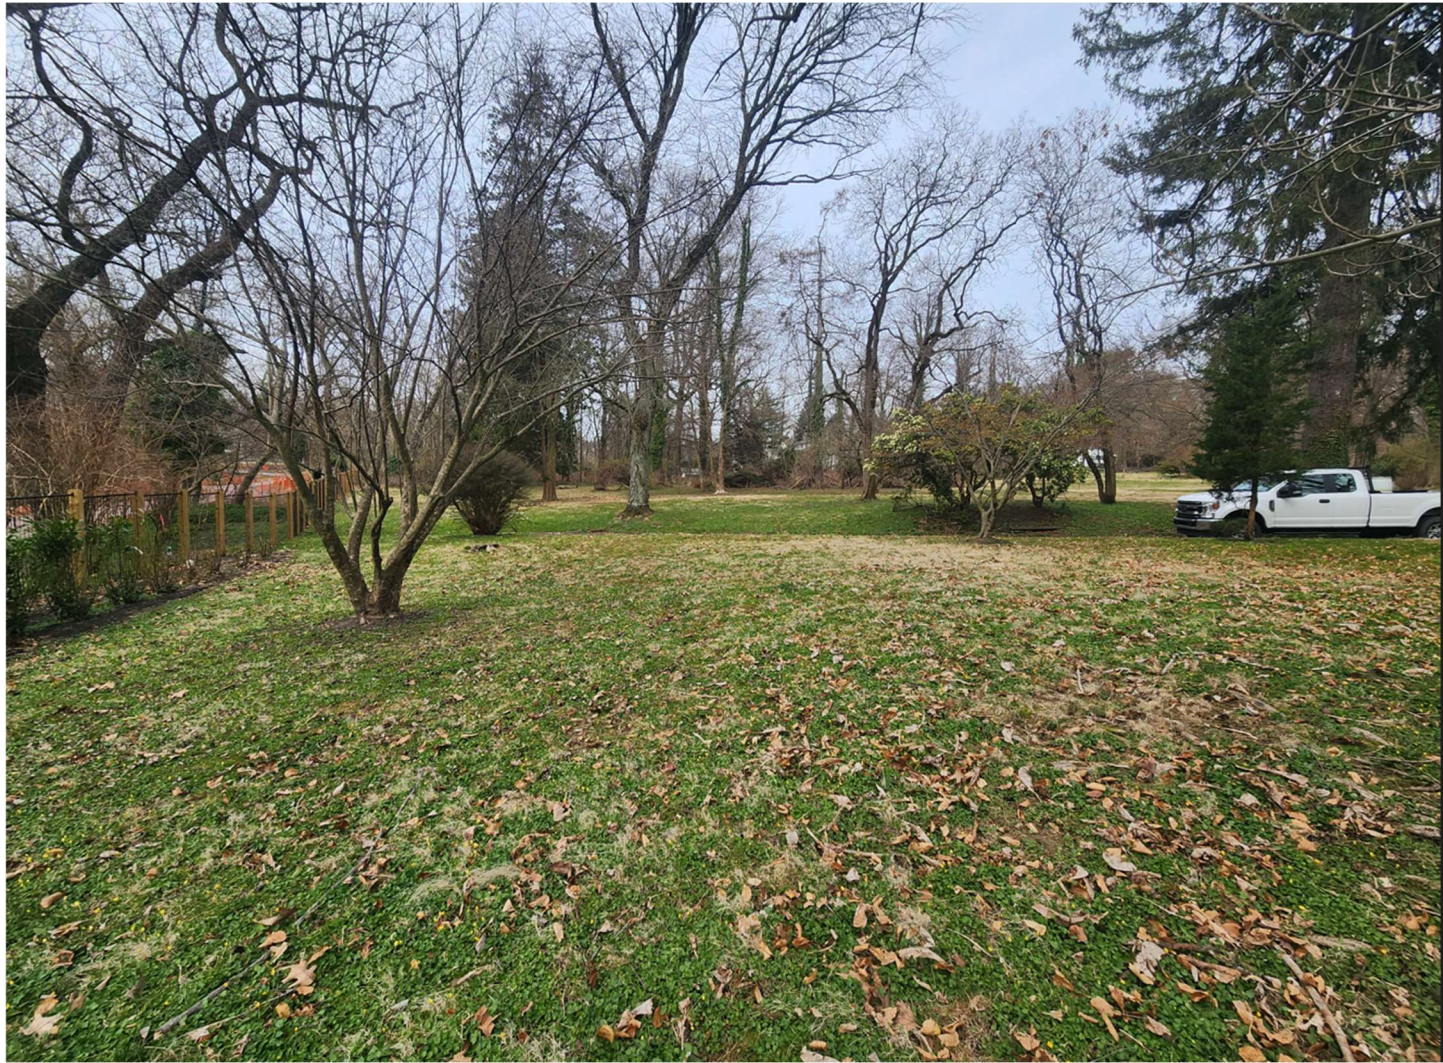
**Photo 3: Typical Upland Lawn Condition**

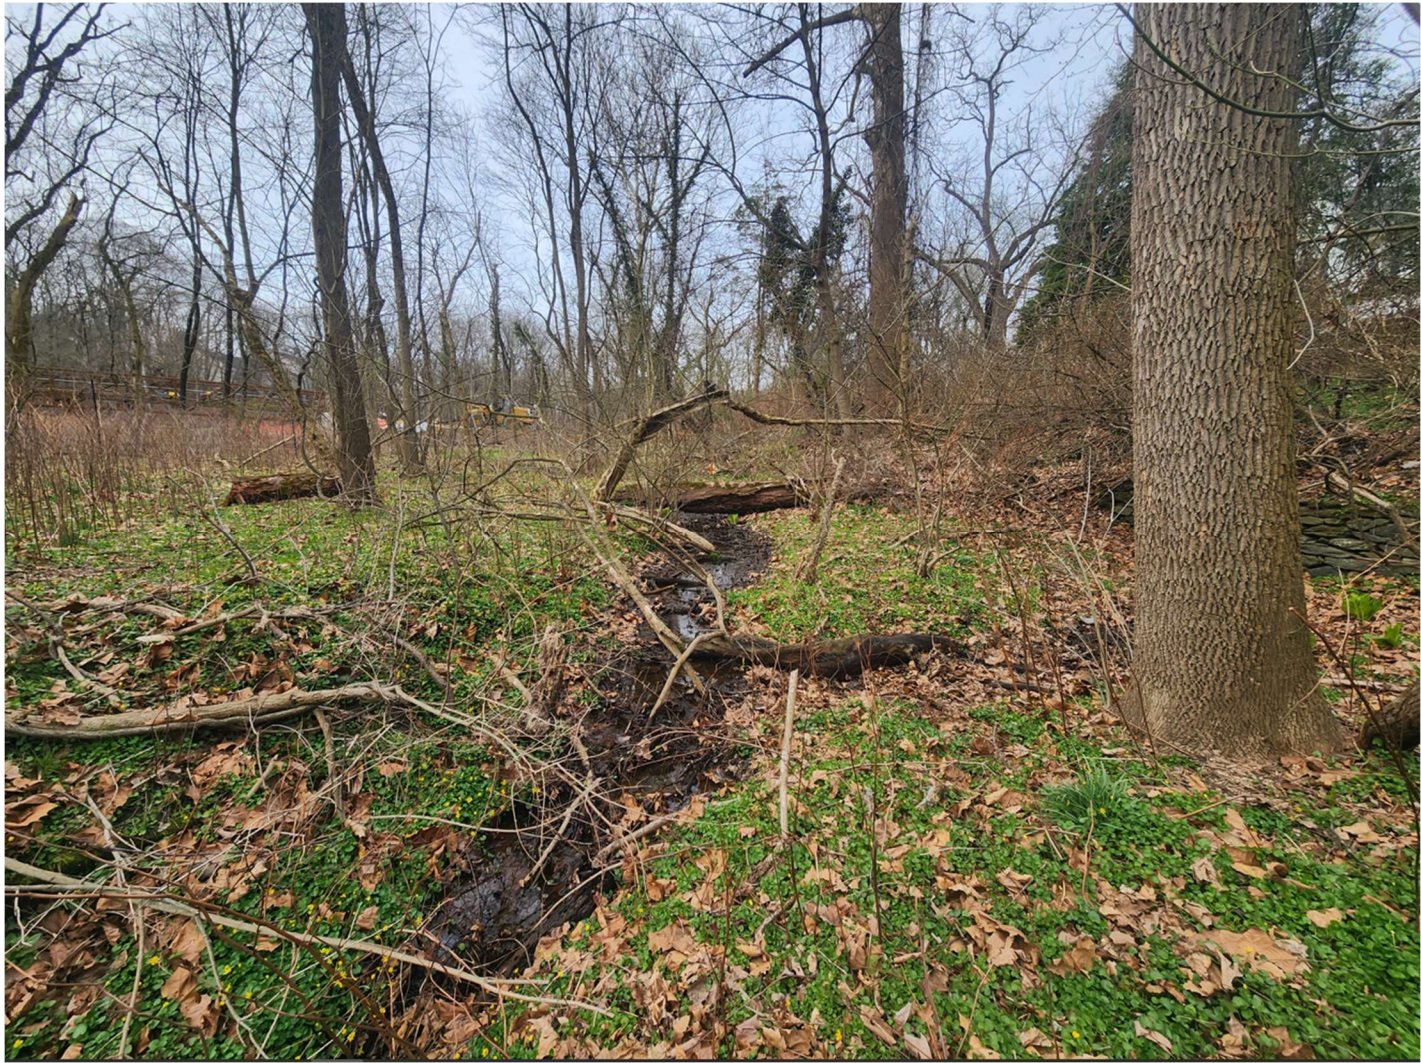
A natural wetland located at the rear of the Tookany Creek floodplain is present along the toe of the raceway berm. This wetland extends off site to the south. A surface connection from the raceway wetland to the floodplain wetland is present in the form of an erosion channel through the berm. The hydrology source of the floodplain wetland is regional groundwater discharge. The connection with the raceway appears to have minimal impacts on the floodplain wetland hydrology and characteristics. Dominant plants include Eurasian butter cup and boxelder maple, along with skunk cabbage (*Symplocarpus foetidus*) in the most lowlying locations.

**Photo 4: Wetland within Floodplain; Facing West**
